Application of the ultrasonic transmission tomography for inspection of the petroleum tank floor

R. Raišutis, R. Kažys, L. Mažeika, R. Šlīteris

Ultrasound Institute, Kaunas University of Technology, Lithuania

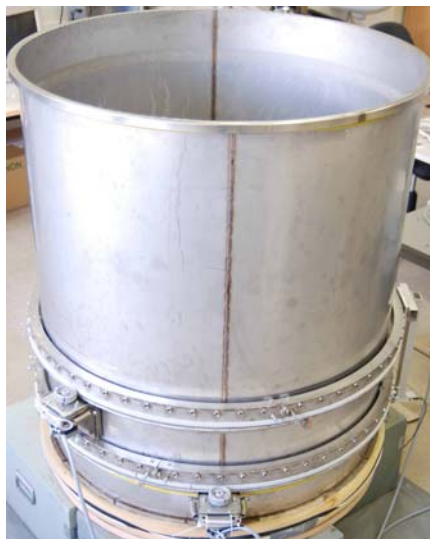
Fig.2. Photo of the 1:8 scaled down size tank mock-up (a) and the measurement set-up (b) used for investigation

For experimental investigation the scaled down size tank mock-up (scaling factor 8:1) placed on wet sand and filled with water was selected (Fig.2a). The internal diameter of the tank was 1 m, the height 1.1 m, the thickness of the floor plate was 1 mm. The experimental set-up used in the investigation and the plates arrangement of the welded floor is presented in Fig.2b.

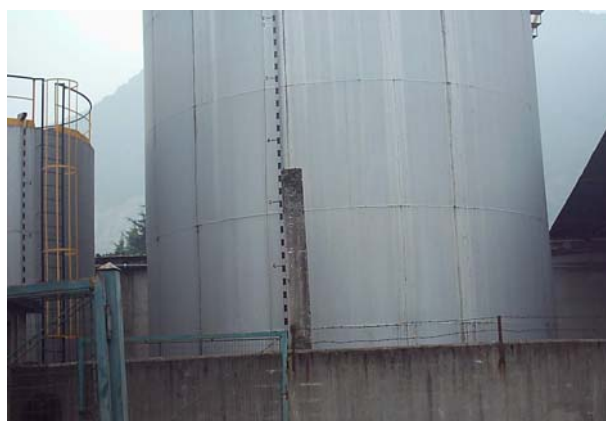
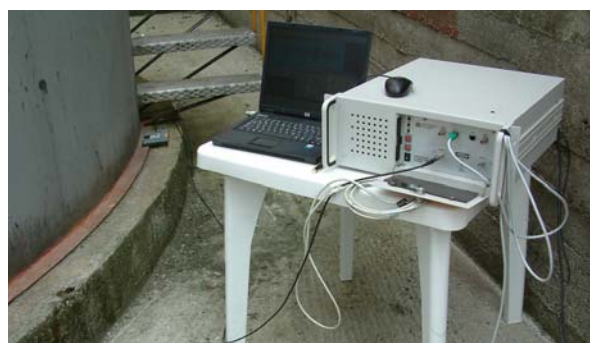
Fig.5. Application of the transmission tomography for inspection of a petroleum tank floor: a - photo of the real tank, which is necessary to inspect, b - experimental set-up, c - the transmitter and receiver positions during *in situ* experiments

In order to estimate the performance of the developed reconstruction algorithm, the experimental measurements have been carried out *in situ* on a small 8 m diameter tank (Fig.5 a), with the step 25 cm along the circumference of the tank floor. The total number of measurement points was 441. In the measurements 50 kHz ultrasonic transducers were used. The transducers were attached to the edge of the tank floor using liquid coupling and magnetic fixing. The tank floor edge was prepared in advance by grinding. For the signal excitation and reception the ultrasonic imaging system developed by the Ultrasound institute of Kaunas University of Technology was used (Fig.5 b). The transmitters were excited using the three periods burst.

In such a way the number of projections was acquired. The projection in the ultrasonic transmission tomography is assumed to be the distribution of the attenuation versus transmission direction or angle (Fig.5 c) for one transmitter position. In our case the transmitter was attached to the edge of the tank floor on one side and receivers were placed at different points on the opposite side of the tank floor covering approximately 180° sector. At each position from the acquired signals the relative attenuation (losses) are measured. The other projections are acquired in a similar way, only the transmitter is attached to the edge of the floor at different positions with some step from the previous one and the measurements on the opposite side of the tank in a corresponding sector are performed. In general, the tomography requires as much as possible of different projections, because the accuracy and resolution of the reconstructed images depend on the number of projections. On the other hand, the accuracy depends on the wavelength of the exploited Lamb wave. So, the optimal number of projections should be determined for each particular case. During investigations 9 tomographic projections were acquired (Fig.5 c). To increase reliability and reduce a noise at each point 11 measurements were performed.

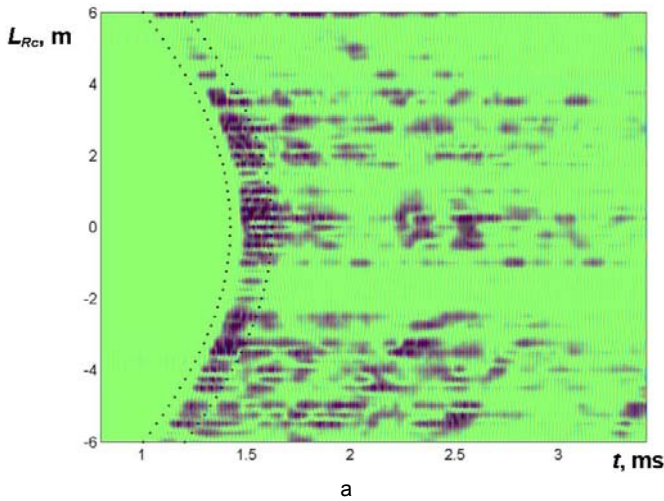
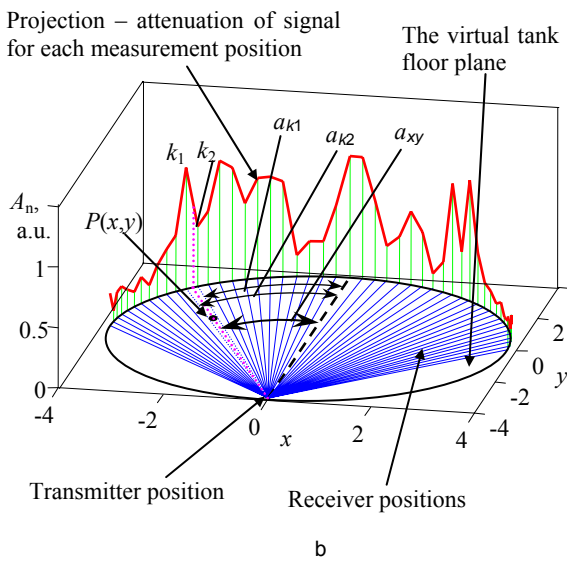
Fig.6. Information extraction from the data collected around the tank floor: a - explanation of the backprojection of the single projection in the virtual tank floor plane, b - the B-scan image of the signals measured at one position of the transmitter. Black dots denote boundaries of the time window for S_0 mode selection: L_{Rc} is a distance along edge of the tank floor.

was calculated and the approximate directivity pattern was obtained. This function will be used as the projection for tomographic reconstruction of distribution of the attenuation in the tank floor (Fig.6 b). In this figure a_{xy} is the angle of the point $P(x,y)$ under analysis with respect to the projection, a_{k1} and a_{k2} are the angles of the closest point of the projection, k_1 and k_2 are the numbers of the closest measured points, A_n is the normalized amplitude. The backprojections obtained from the data acquired at different transmitter positions are integrated and the final reconstructed image is obtained.

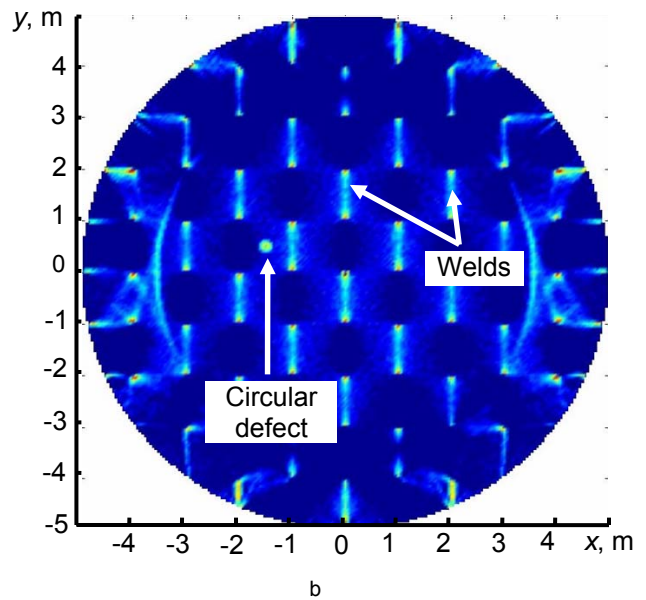
Fig.7. Spatial localisation of the tank floor non-uniformities by ultrasonic transmission tomography: a - ultrasonic image of the petroleum tank floor reconstructed from the experimental data. The areas of the intensive colour correspond to the zones with an essentially higher attenuation of the S_0 mode Lamb wave, b - reconstructed ultrasonic image of the petroleum tank floor with a circular defect (from simulated data)

The experimentally obtained spatial distribution of the attenuation of propagating Lamb waves in the floor of the real tank is presented in Fig.7 a. The darker areas correspond to the zones with a higher attenuation of S_0 mode Lamb waves, what is correlated to large corroded areas. The resolution of the presented image depends on the number of projections used in the tomographic reconstruction.

tank floor centre. It was assumed that it causes the 4dB losses of the Lamb waves transmitted around it. The reconstructed image of the non-uniformities in a tank floor is presented in Fig.7 b. The positions of all welds are seen precisely. The absence of horizontal welds can be explained by specific features of the reconstruction algorithm and the fact that these welds are linear across the whole tank floor. The exact position of the defect can be seen precisely as the bright circular spot in the image.
