Detection of crack in a concrete element by impact-echo method

Abstract

Demonstrative experiment was done to verify ability of the impact-echo method to detect discontinuity, honeycombing or any defect in a concrete structure. Two beams of the length 7.5 m were investigated, the first one with an evident shear crack, the second one without visible deterioration. Observation confirmed assumptions and in the depth 2,0 m a discontinuity was detected.

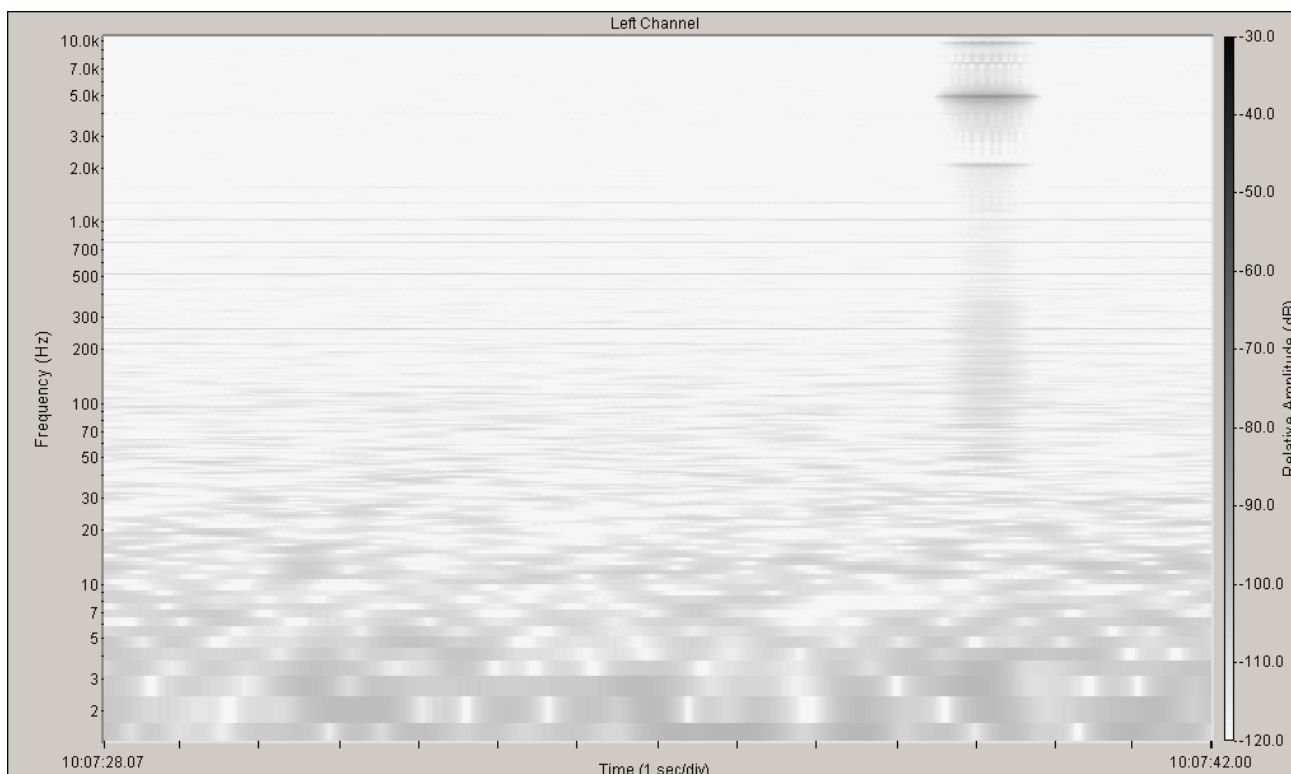
Fig 3. Spectrogram signal record in wider circumstances with the echo of a short impact on the forehead of the first prism

iii) Spectrogram shows amplitudes of the signal in degrees of grey scale or in colour. Each point has its position on the frequency- and time axis. Therefore the spectrogram shows actual intensities of the signal within different frequencies versus time (Fig 3).
