Non-destructive testing evaluation of low velocity impact damage in carbon fiber-reinforced laminated composites

Abstract

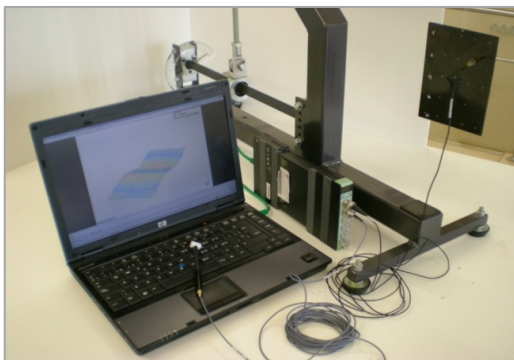
Fig. 1. Assembly made for modal testing

The experiments were conducted using a Brüel & Kjaer type 4518-003 uniaxial accelerometer, whose mass is less than 1,5 g, along with a miniature transducer hammer Brüel & Kjaer model 8204 for the excitation of the system. Due to the accelerometer being attached to the test specimen, there is a certain amount of mass that is added to the structure. It is important to assure that the mass of the transducer is negligible when compared with the effective modal mass of a mode of vibration so as not to interfere with the vibrational behavior. Both the applied excitation and the measured response were perpendicular to the plate. The range of frequencies studied was between 5 and 10000 Hz with a resolution of 0,125 Hz. The data acquisition system was a Brüel & Kjaer model 3050-B-6/0. An analysis of the measurements was performed using Brüel & Kjaer PULSE v.14, and for the estimation parameters, the modal and structural analysis software ME'Scope VESTM 7754 was employed. Fig. 1 shows the measurement set-up for modal testing.

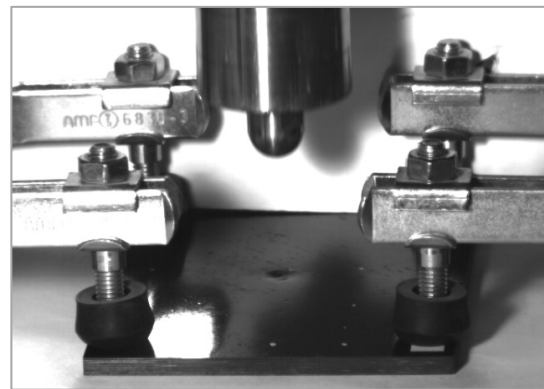
Fig. 2. Drop-weight impact-testing device utilized

The specimen was placed in the rigid support fixture, centered relative to the cut-out and was secured in place using the four rubber-tipped clamps, positioned at 25 mm from the specimen edges, in order to prevent the specimen from rebounding during impact event. Figure 2 shows the drop-weight impact-testing device utilized. The impact device includes a rigid base, a cylindrical drop-weight impactor and a cylindrical guide mechanism. A rebound catcher is used to stop the impactor during its second descent.

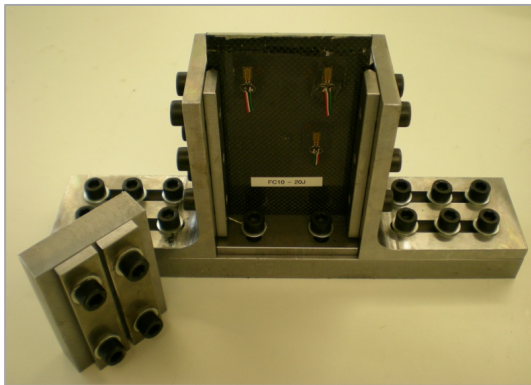
Fig. 3. Compressive residual strength support fixture with specimen in place

stabilization fixture. The test equipment utilized in this work meets the requirements of the standard outlined in the ASTM D7137 [12]. The compressive test is undertaken in a multi-piece support fixture, which utilizes adjustable retention plates that provide no restraint to local out-of-plane rotation, to support the specimen edges and inhibit buckling when the plate is end-loaded. The top and bottom supports provide no clamp-up, but provide some rotational restraint due to the fixture geometry. The compressive residual strength support fixture is shown in Figure 3. It has been carefully aligned in order to minimize loading eccentricities and induced specimen bending.

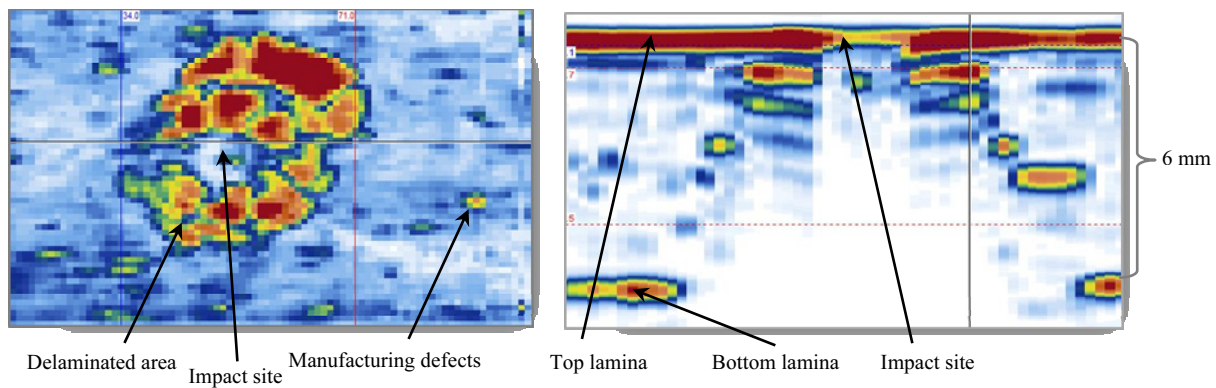
Fig. 4. Ultrasonic C-scan (left) and B-scan (right) of a specimen after 40 J impact.

Fig. 4 illustrates ultrasonic C-scan (left), showing the surface location and B-scan (right) indicating the depth damage of a specimen after 40 J impact. Delaminations occur at the interface of adjacent laminas. The C-Scan results prove that impacts generate oblong shapes radiating from the impact site with the major axis aligned with the fiber orientation. The superposition of these oblong delaminations is the ellipse represented in the left hand figure. Small discontinuities out of the damaged area are due to manufacturing defects. Through thickness damage information are illustrated by B-scan. Damage is characterized by a conical shape originated at the contact site. As can be seen, damaged area is significantly lower in those plies closer to the impact point. It should be note that if multiple delaminations are induced, ultrasonic scanning will only determine the depth and shape of the delamination closest to the surface.

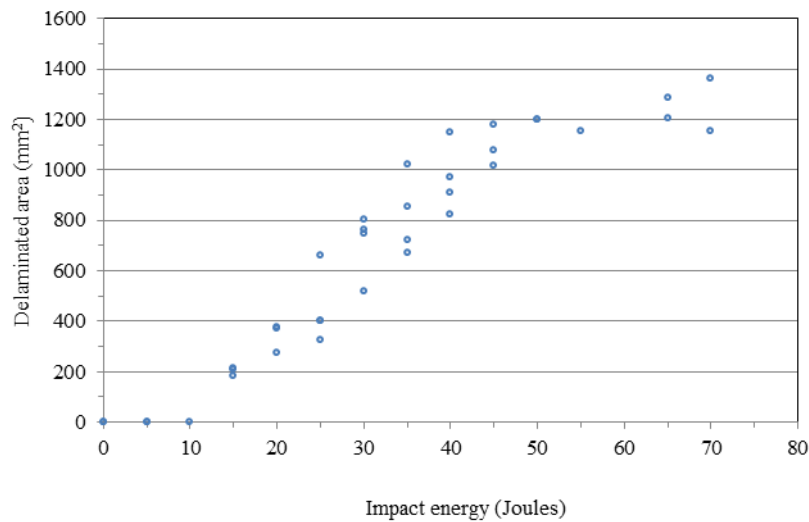
Fig. 5. Projected delamination area versus impact energy

Phased array results require image manipulation and assessment of contours to obtain the projected delamination area. In Fig 5, the damaged area as a function of an impact energy for each specimen has been represented. Inspection shows that below 15 J, force for onset of delamination has not been achieved and consequently no damage has occurred. After threshold is

reached, delamination area increases linearly with the impact energy. Increase in damaged area can be attributed to the increase in bending induced shear stresses. The change in trend beyond 50 J is supposedly due to the influence of the impact support structure.

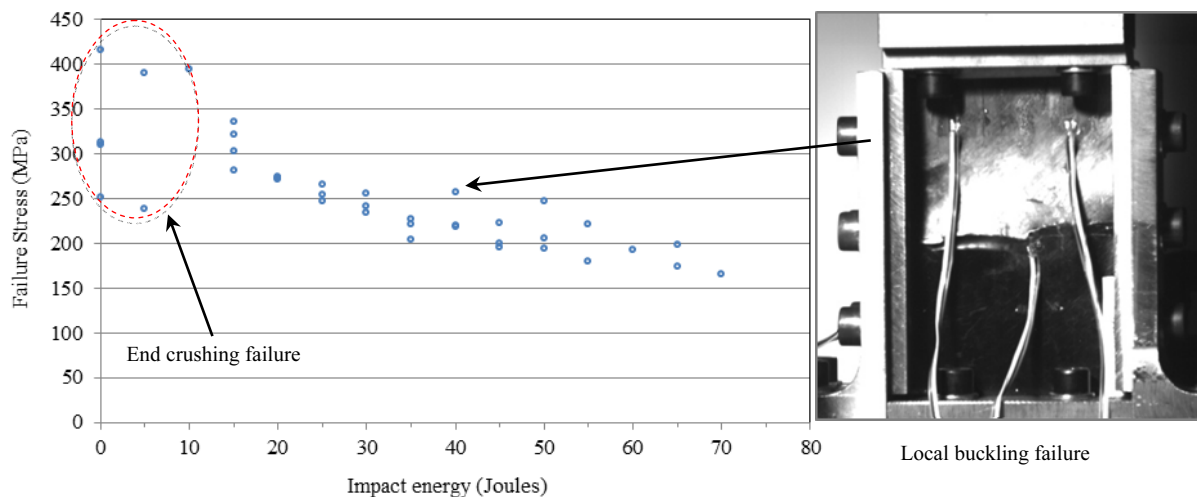
Fig. 6. Projected delamination area *versus* impact energy and local buckling failure with kink bands

Fig. 6 shows the compressive strength after impact as a function of impact energy. As can be seen, once the impact

energy exceeds the critical threshold, the compressive strength reduction is significant. An attempt was made to employ the support fixture to test undamaged specimens (below 15 J), but such tests demonstrated a relatively high incidence of undesirable failure modes such as end crushing. The right hand figure illustrates an example of local buckling failure with kink bands, one of commonly acceptable compressive residual strength failure mode.

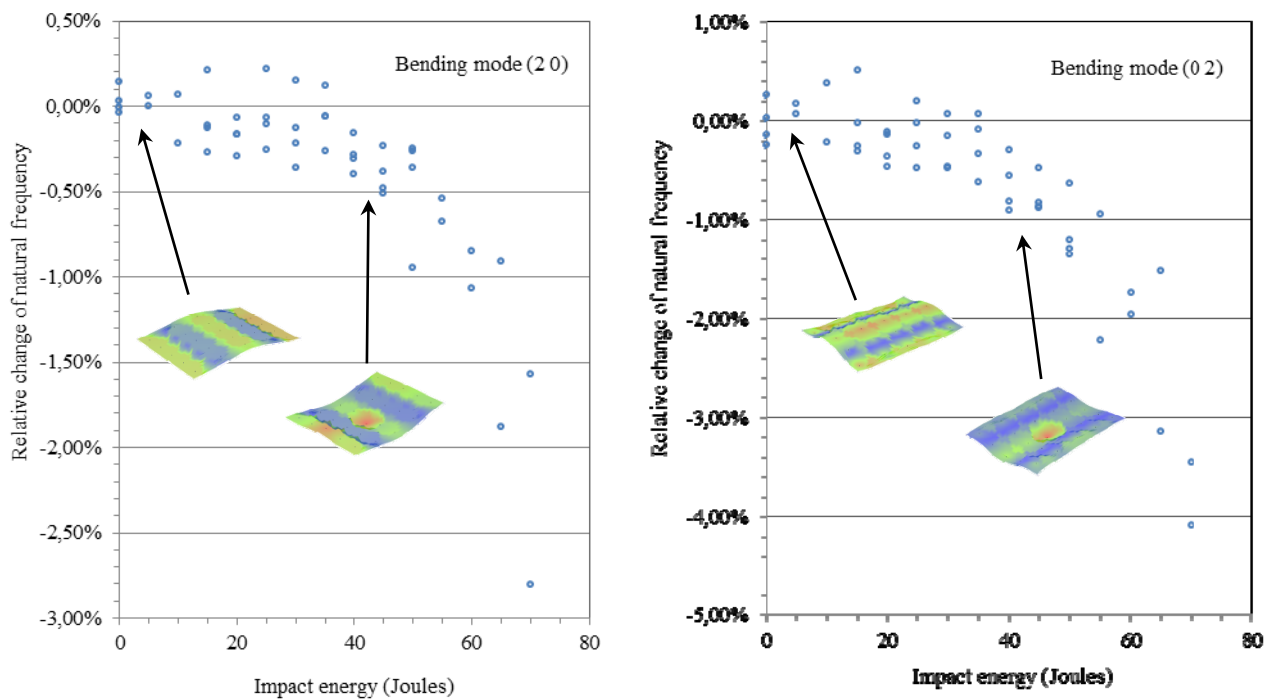
Fig. 7. Relative changes of natural frequencies of the bending modes (2 0) and (0 2) as a function of impact energy under free boundary conditions

Fig. 7 represents relative changes of natural frequencies of the bending modes (2 0) and (0 2) as a function of impact energy under free boundary conditions. Mode's nomenclature (m, n) identifies the different mode types, where m and n refer to the number of nodal lines parallel to y direction and x direction, respectively. Although 10 modes were measured, only two of them are represented. As can be observed, results show a systematic decrease of natural frequencies with increasing impact energy. However, not all natural frequencies are equally affected by impact damages. The most significant variation is found in the higher modes or in which damaged areas are not located on a nodal line. Measuring higher modes

Small increases of the natural frequencies for energies below 40 J, is assumed due to local stiffening and experimentation errors. The sensitivity of the variation in frequency by impact damages can be seen from the 40 J, which corresponds to a projected delaminated area of about 1000 mm² and a reduction of compressive strength of more than 50%.
